INVENTORY
of
POTENTIAL and EXISTING
UPSTREAM RESERVOIR SITES
CHICOPEE STUDY AREA
Massachusetts

U.S. DEPARTMENT of AGRICULTURE
Soil Conservation Service
Economic Research Service
Forest Service

MASSACHUSETTS WATER RESOURCES COMMISSION

MAY 1973

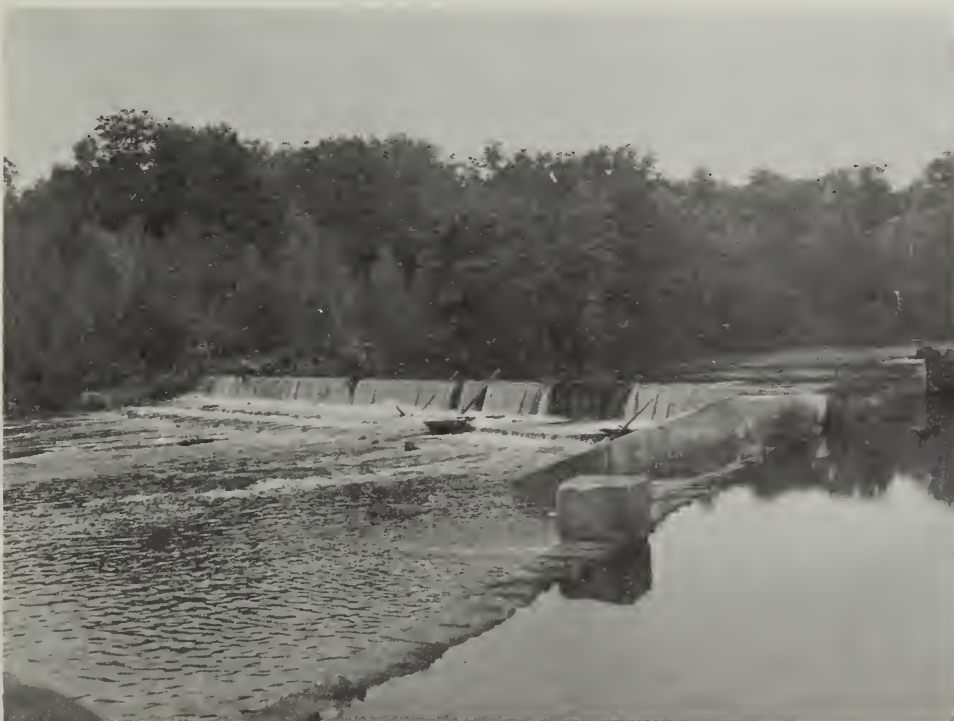
Remarks: The dam is a 300 foot long stone masonry structure. The right 200 feet of the dam is a weir section with flashboards. The left 100 foot section is about 5 feet higher. A gate controls the flow of water to a canal on the left side of the dam.

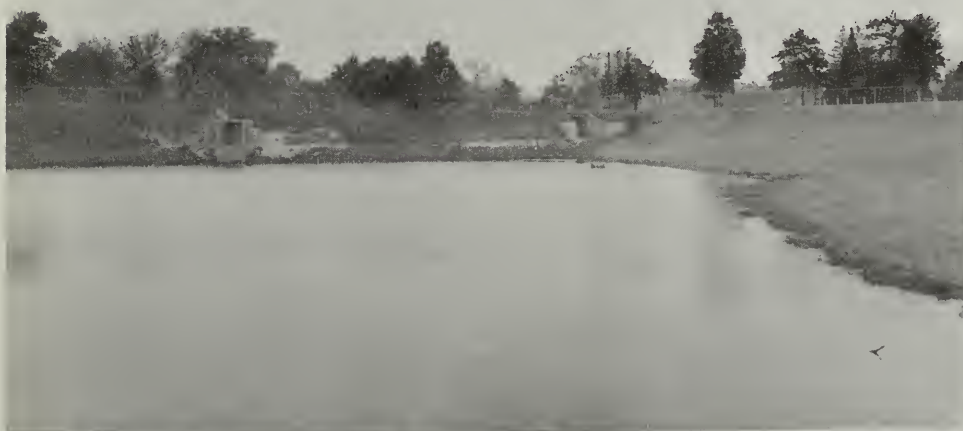
Remarks: The dam is a 350 foot long earth-fill structure with a 14 foot top width. The principal spillway is a concrete drop inlet leading to a 6 foot by 7 foot conduit. The emergency spillway is a 10 foot by 9 foot concrete monolithic conduit. A 40 foot long concrete apron leads to the emergency spillway. Concrete in the apron is deteriorated.

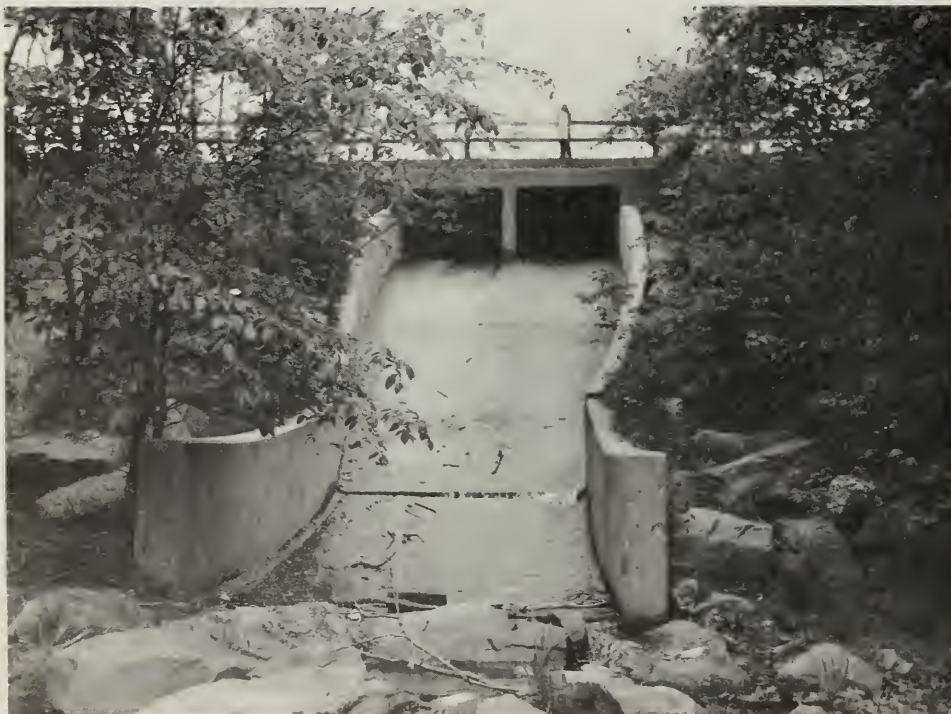
Remarks: The dam is part of the Armory Street Highway embankment. The spillway is twin concrete box culverts, 6 feet high by 17 feet wide with a concrete chute at the outlet. Heavy brush and trees are growing on the downstream slope of the dam. There is seepage through the dam and concrete in the chute sidewalls is spalling.
